MARINE INVESTIGATION REPORT
M01C0054

STRIKING AND SUBSEQUENT FIRE ON BOARD

BRIDGE 11, WELLAND CANAL

BULK CARRIER *WINDOC*

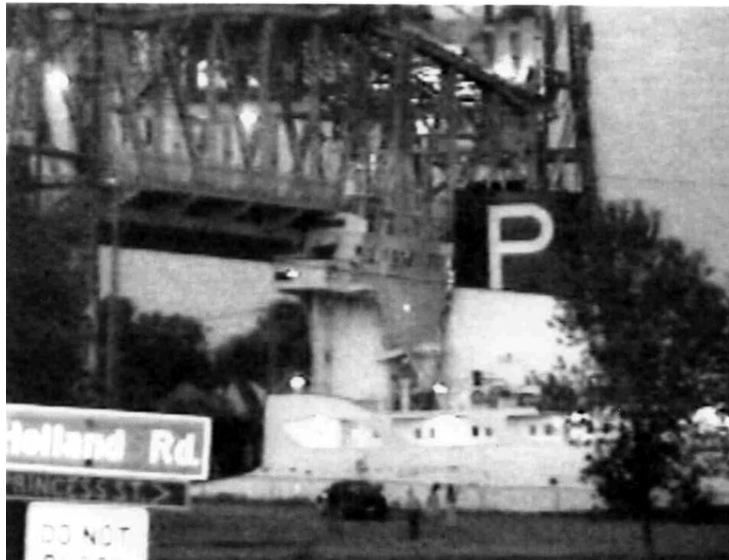
The master and third officer left the wheelhouse by the starboard navigation bridge wing. As they proceeded down the external bridge access ladder, the span of the bridge struck the vessel in way of the wheelhouse front windows, subsequently destroying the vessel's wheelhouse and funnel (see Photo 1).

Photo 1. Bridge 11 striking vessel in way of wheelhouse front windows. Reproduced with permission.

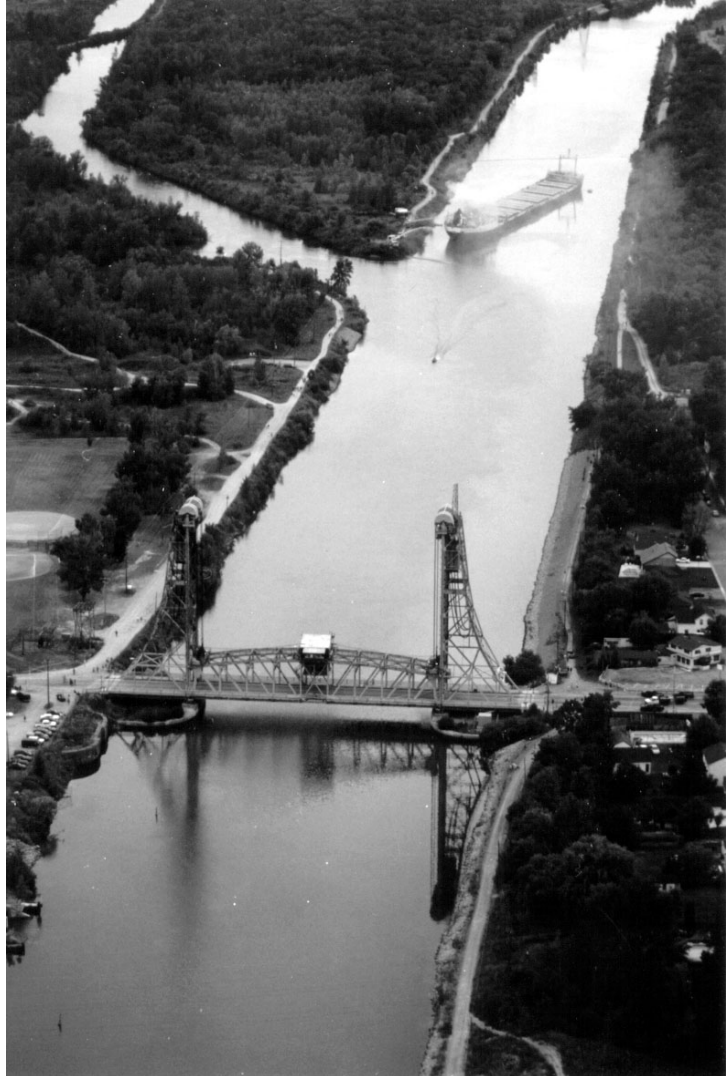
Photo 2. Aerial view looking north at the bridge and vessel after the striking. (Photograph by Harry Rosettani)

The vessel drifted downbound from Bridge 11. A fire broke out in way of the main engine casing and spread to the accommodation structure. The starboard anchor was dropped. However, the vessel's starboard bow made contact with the east bank of the canal. The vessel then drifted to the west side of the canal and went aground approximately 800 m from Bridge 11 (see Photo 2).

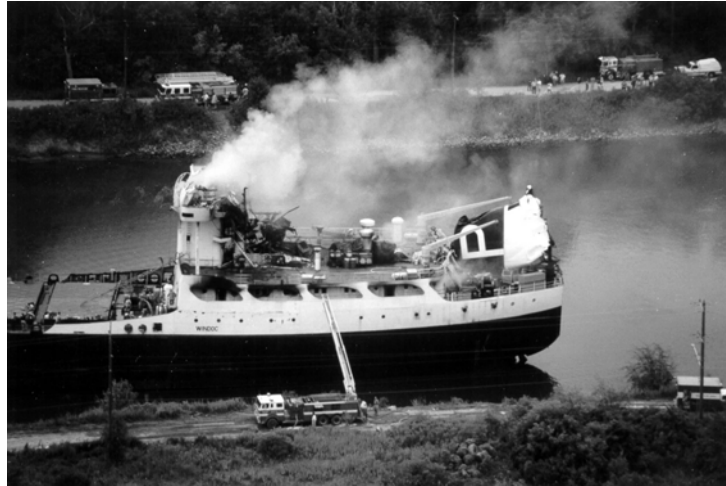
Photo 3. Aerial view of aft section of vessel with fire department vehicle on site. (Photograph by Harry Rosettani)

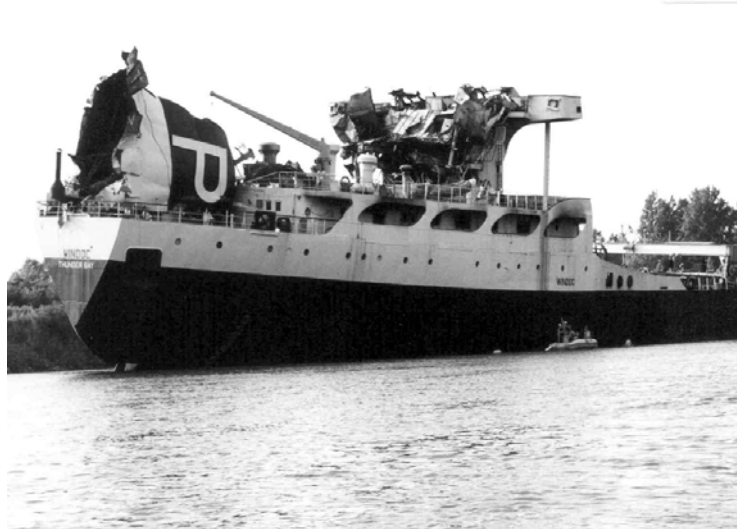
The wheelhouse, main mast, engine room vents, and funnel were destroyed by contact with the lift span of the bridge. The incinerator fuel oil tank, located in the funnel casing, was ruptured, spilling fuel into the engine room and onto the boat deck.

Accommodation on the various decks was destroyed by fire, heat, and smoke. The engine room casing and main engine were damaged by fire, heat and water. The bilge shell plating in way of starboard ballast tank No. 1 was creased and fractured. The aft bulkhead and bilge floors were distorted and torn adrift. The vessel was declared a constructive total loss. No damage to the cargo was reported (see Photo 4).

Photo 4. View of damaged superstructure and funnel.

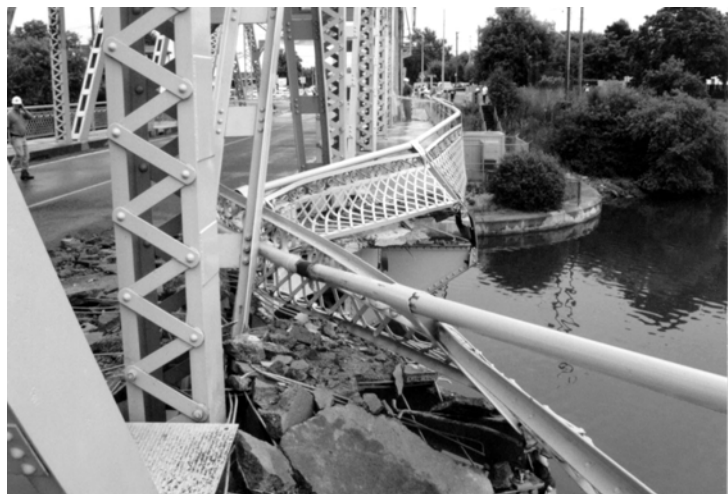
The bridge sustained structural damage to the centre of the vertical-lift span (see Photo 5). There was also damage at the extremities of the span as a result of lateral movement caused by the striking.

Other than minor adjustments on the wire ropes which operate the bridge, there was no damage, mechanical or electrical, to the bridge's systems.

Photo 5. Damage to Bridge 11. (Photograph by Thorold Fire Department)

Repairs to the bridge were carried out while the vertical-lift span was in the fully-raised position to permit vessel traffic to transit the canal. Upon inspection by SLSMC engineers, the bridge reopened to vehicular traffic on 16 November 2001.

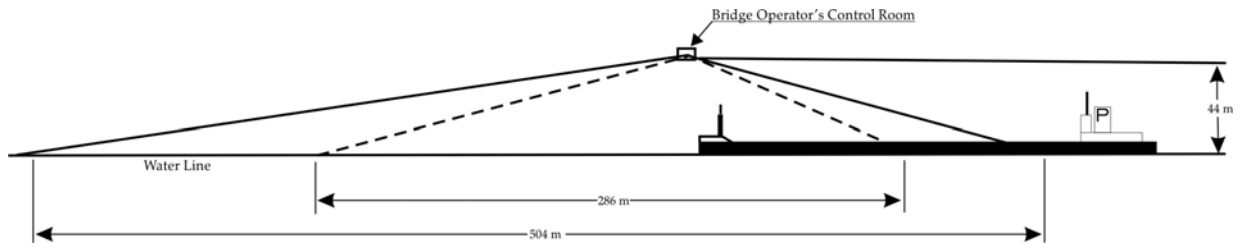
span. The approaching vessel's aft superstructure would have been visible to the bridge operator (whether seated or standing) through the south-facing control room window (see Figures 1 and 2, Photos 6 and 7).

Figure 1. Diagram of a bridge operator's field of view when the bow of the vessel is under the operator's control room. Bridge is in the fully-raised position.

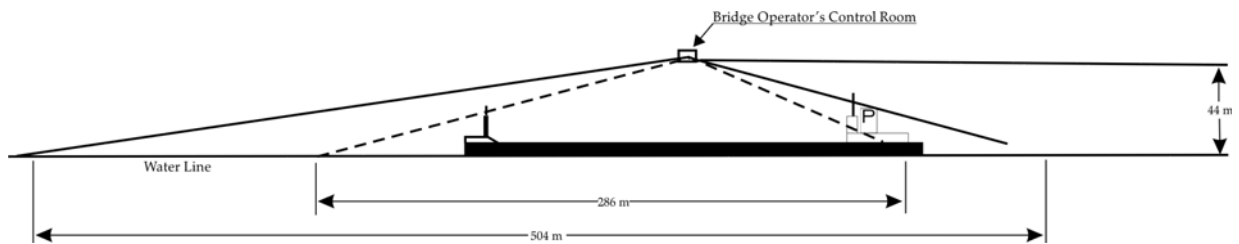
Figure 2. Diagram of a bridge operator's field of view when the vessel is amidships under the operator's control room. Bridge is in the fully raised position.

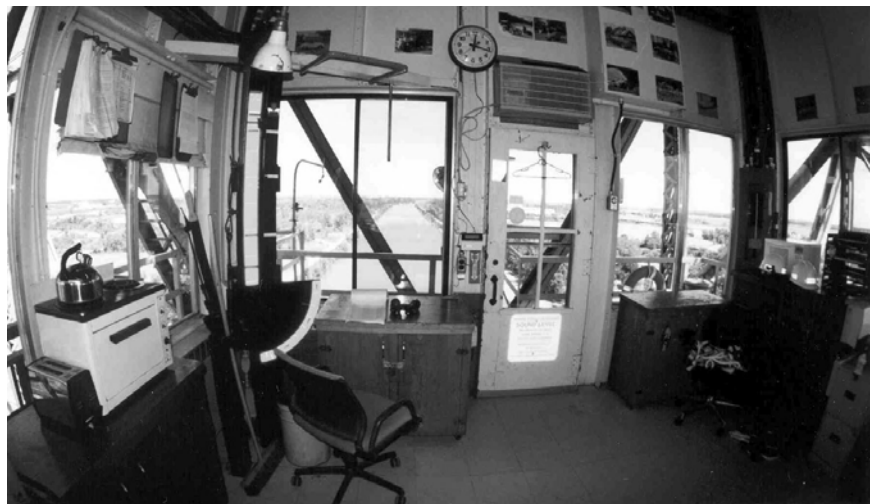
Photo 6. Looking north from inside bridge operator control room with bridge in fully raised position (using fish-eye camera lens).

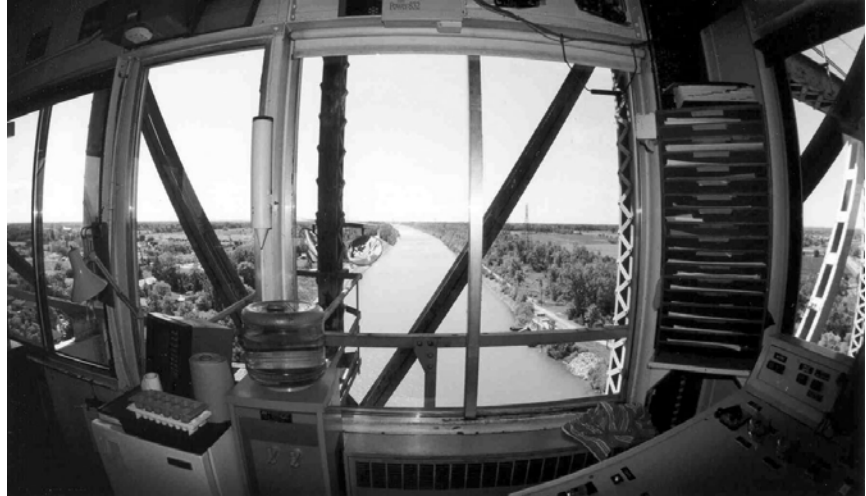
The SLSMC's operations manual for Bridge 11 states that the bridge may be lowered when it is observed that the stern of the vessel is clear of the bridge.⁷ The bridge operator described having seen the stern of the vessel through the north windows of the control room (i.e. looking downstream the canal) where the door is located.

Photo 7. Looking south from inside bridge operator control room with bridge in fully raised position (using fish-eye camera lens).
